The Architecture of The William Trent House

By Kevin Joy

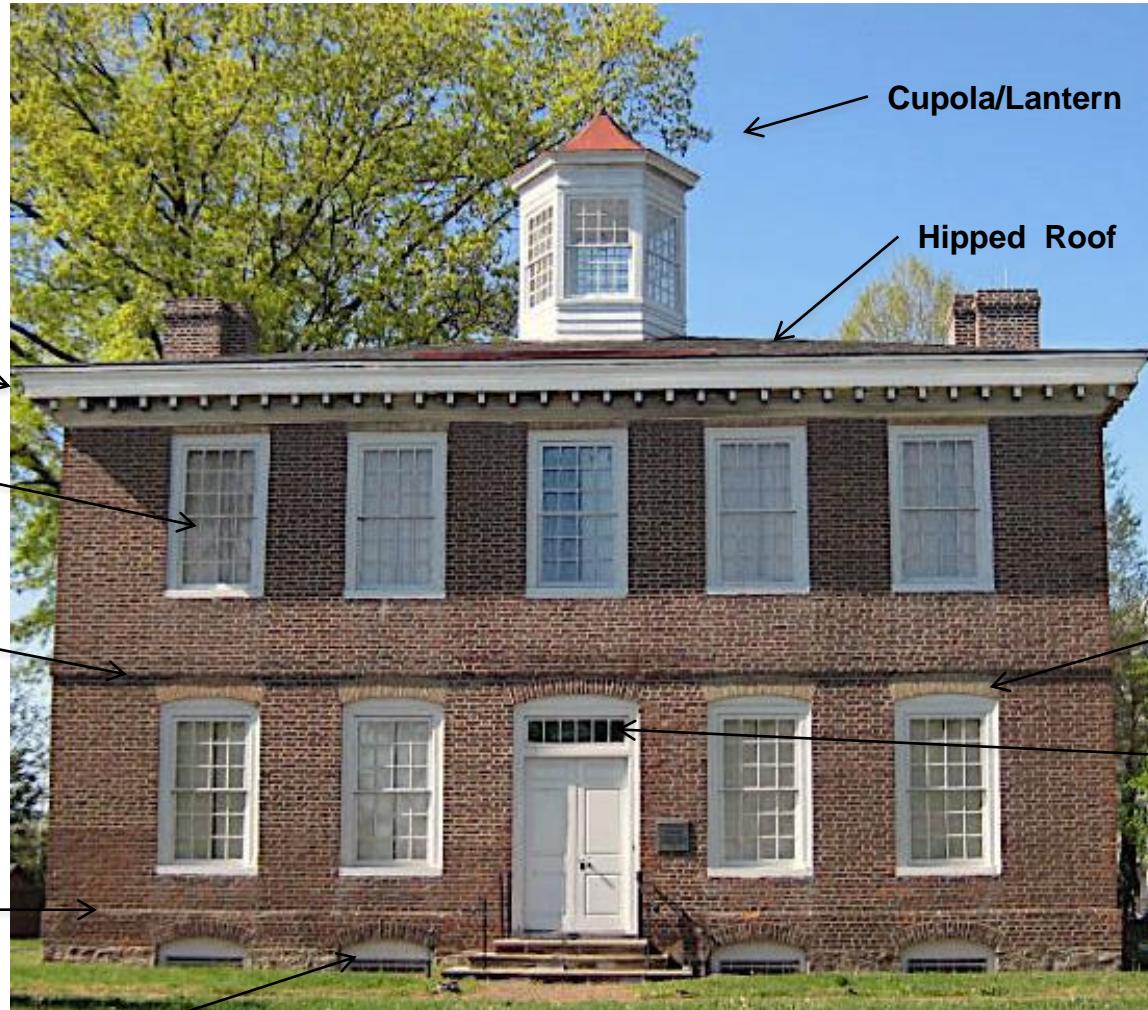
Elements of Georgian Architecture

Cupola/Lantern

Hipped Roof

Classical Cornice
w/Modillions

Multi-paned Glazing (12
over 12)

Belt Course

Segmental Arch
over Window

Multi-paned
Transom

Molded Brick Water
Table

“English” Basement

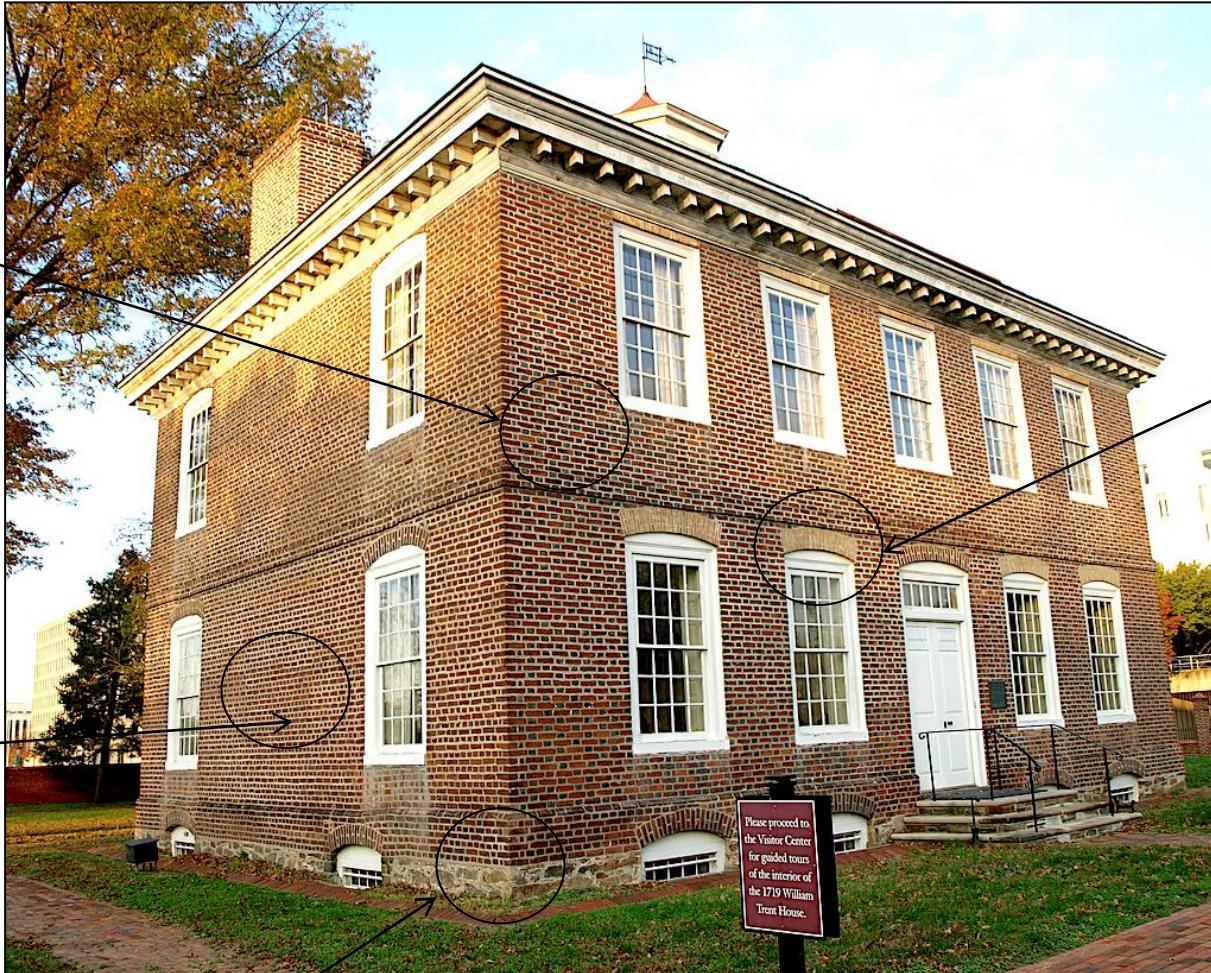
Brick work Details

Flemish Bond

English Bond

Raised Stone Foundation

Segmental Arch with Dutch Bricks

◆ Bricks likely made on premises or nearby, with the exception of the Dutch bricks.

◆ Original lime mortar has been mostly replaced by Portland cement.

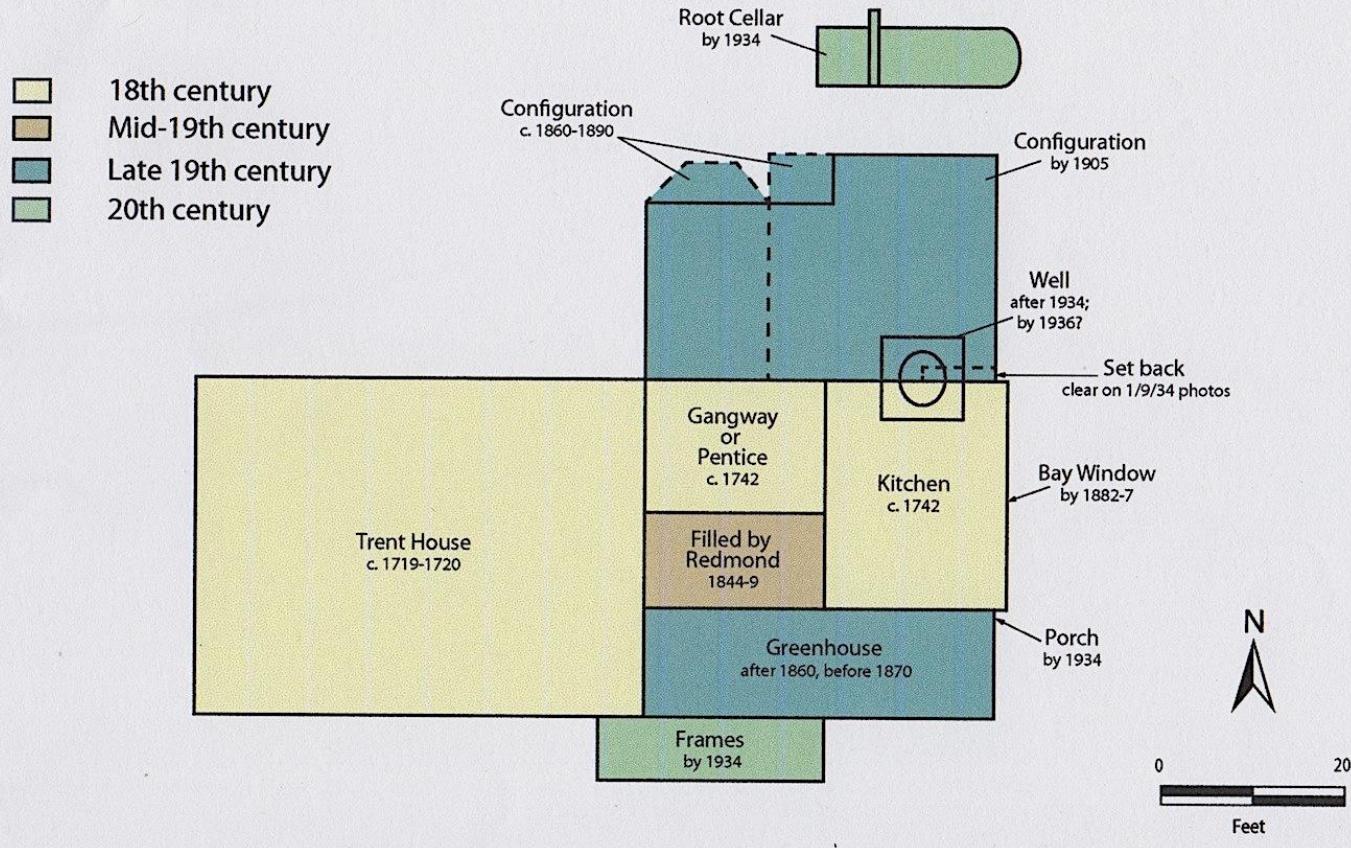
**Fig. 1: Structural History and Configuration of the East Wing of the Trent House
(After Maxman 1997 and Hunter Research, Inc.)**

Notes: Noble Preservation believes 1719/20 construction date cannot be confirmed.

- There was a second greenhouse constructed on the same site after 1887.
- Well head is believed to be original to c.1742 kitchen addition.
- A frame addition is believed to have existed off western elevation of original house.
- Porches existed after c.1815-1835 on both north and south facades of original house

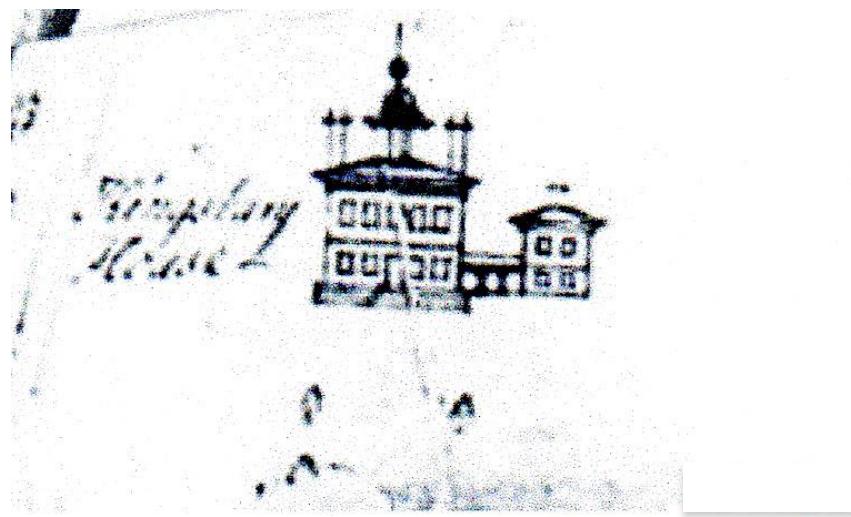
"Kingsbury House"

Sketch of the Trent House from "A Plan of Colonel Thomas's Estate, Kingsbury in West Jersey"
THIS SKETCH OF "KINGSBURY HOUSE" IS THE EARLIEST DEPICTION OF THE TRENT HOUSE.
Note kitchen addition with gangway, hipped roof and center chimney.
Also note lack of basement windows.

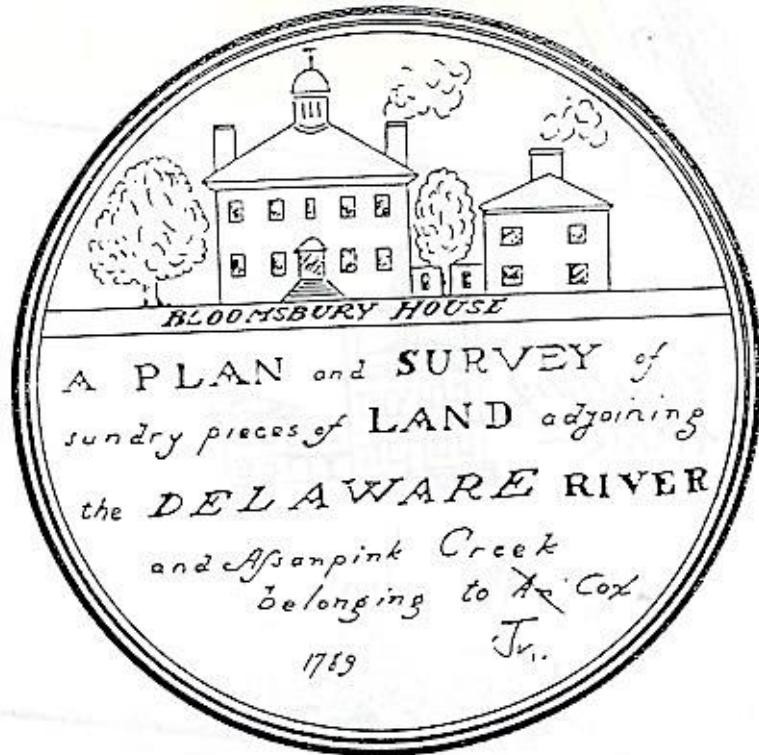
1789

Sketch of the Trent House (Bloomsbury House at the time...) from "A Plan and Survey of sundry pieces of Land adjoining the Delaware River and Afsanpink Creek belonging to Jn. Cox 1789." Note cupola detail and pediment canopy over the front door

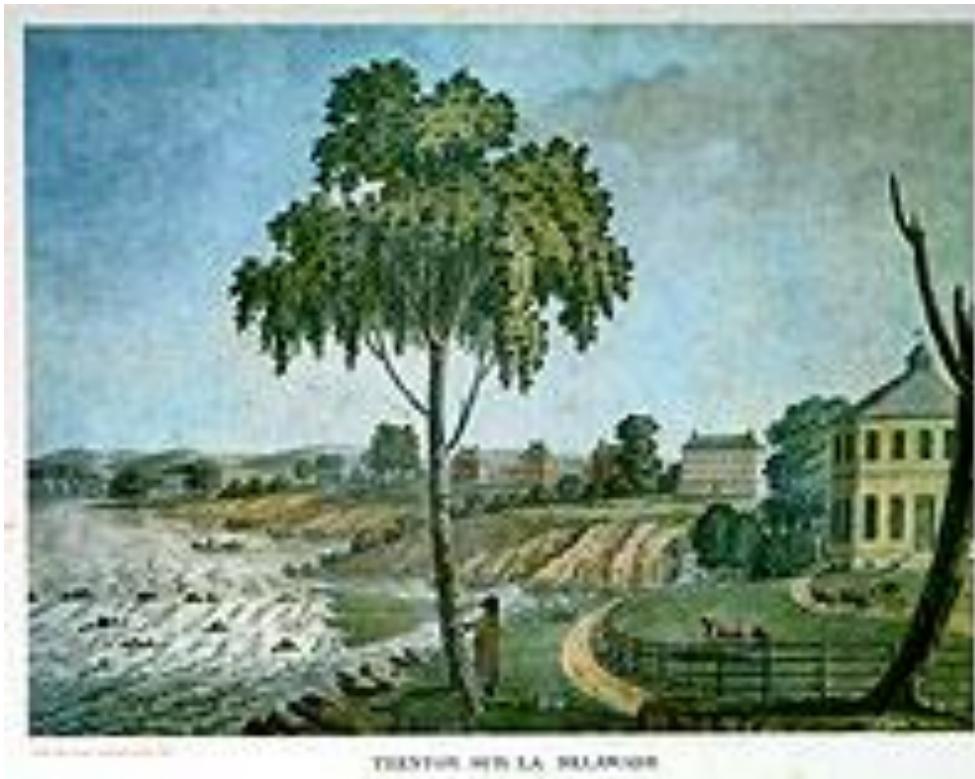
c.1800

"Trenton sur la Delaware." c. 1800 watercolor by Count de Maulevier. Note the facades are painted a cream color rather than the reddish orange (brick?) used for most of the background buildings. The house appears to be painted at the time of this rendering. Also note window and cupola details and that the basement windows are now present.. No pediment visible over door.

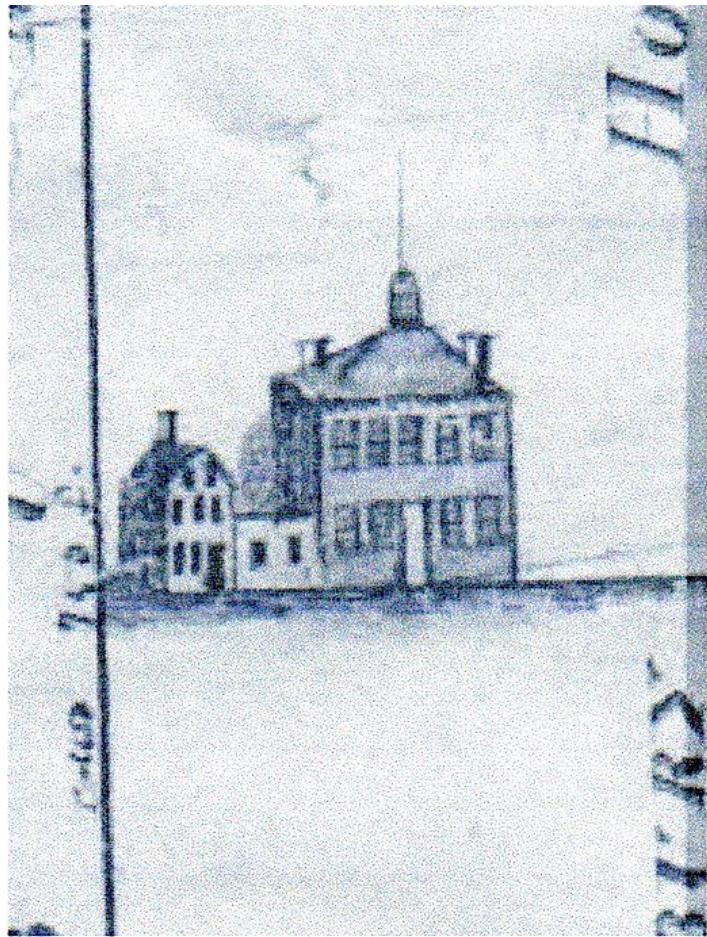
c. 1804 [c. 1815-1835]

Tracing of “A Plan of Sundry Lots of Land the Property of Daniel W. Coxe Esquire Part of His Bloomsbury Estate, probable date – 1804.” Here it appears evident that the north elevation has become the main elevation/entrance. This is the first image of this elevation. Note the apparent flaws in the depiction of the kitchen addition: a 2 ½ register, gabled roof rather than a 2 register hipped roof structure. The divided light windows are now visible.

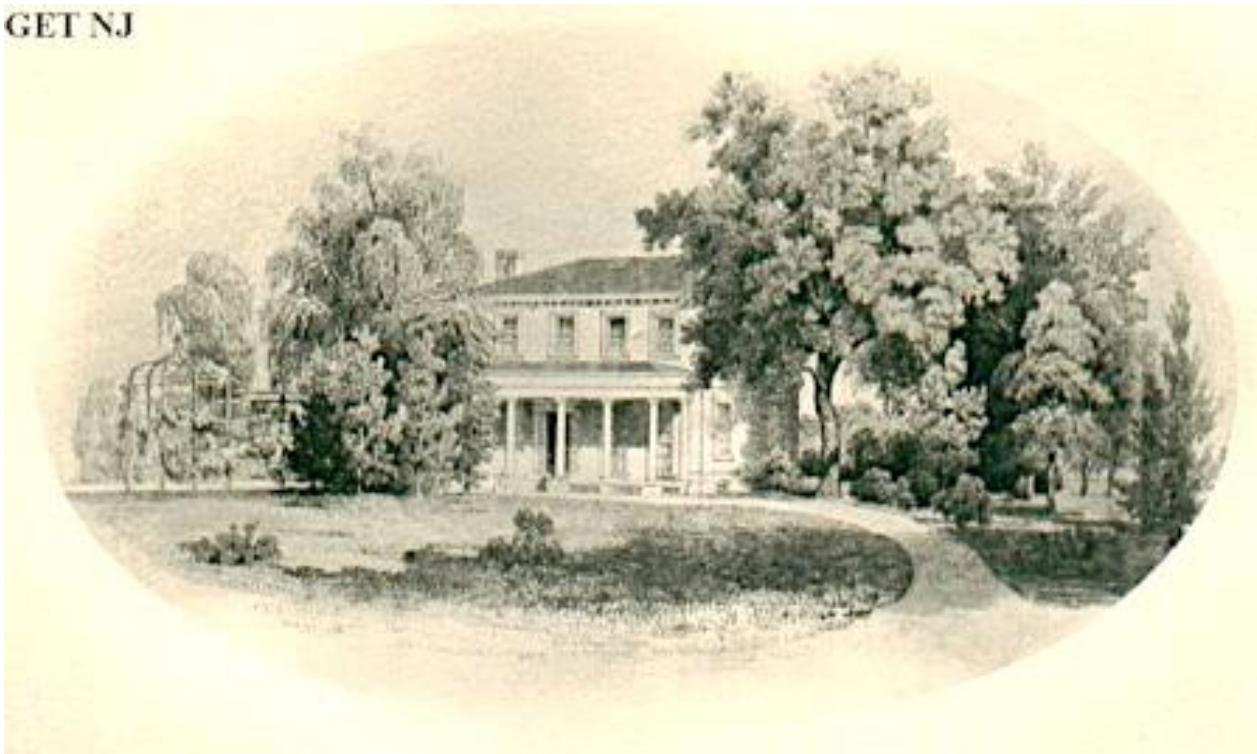
Bloomsbury Court

An 1850 mounted engraving of the north elevation entitled “Bloomsbury Court.”

This engraving is the first image drawn with an attempt to detail the features of the Trent House.
Notes: the addition is just visible through the trees on the left.

The hipped roof appears relatively flat with what looks like a sort of sky light in place of the cupola, which was evidently removed after c.1815-1835. A one-story porch has been added to this elevation, and two floor to ceiling windows are evident on the west side of the front door. These were likely installed when the porch was built. The rest of the windows are depicted as 6/6 divided light double-hung sash with wide trim. Note curvilinear drive.

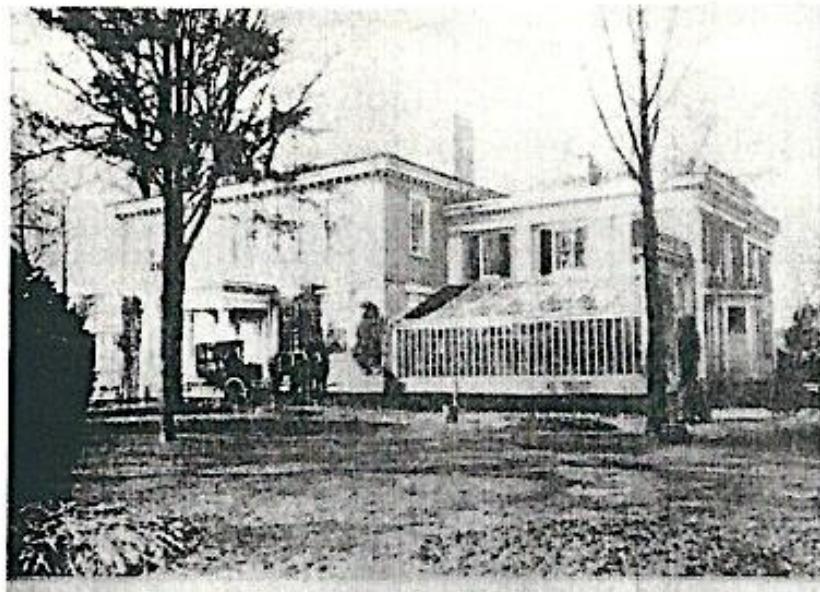
n.d. [c. 1882-1887]

Photograph of the south and east elevations with the caption, "Residence of Edward H. Stokes, Trenton, N.J." This is the first known photograph of the Trent House. Notes: Again, the south elevation has become the main entrance. This is the first view of the south elevation entrance porch, which was added between 1800 and 1874—very likely between c. 1815 and 1850. See also the two-story frame addition on the northeast corner, and the greenhouse and centered brick section on the east elevation. All three sections are crowned with metalwork to tie them together and create a cohesive appearance. This photograph also confirms the 6/6 sash suggested in the previous engraving. The facades of the original section of the house appear to be whitewashed or painted, though this may be an effect caused by the exposure of the photograph.

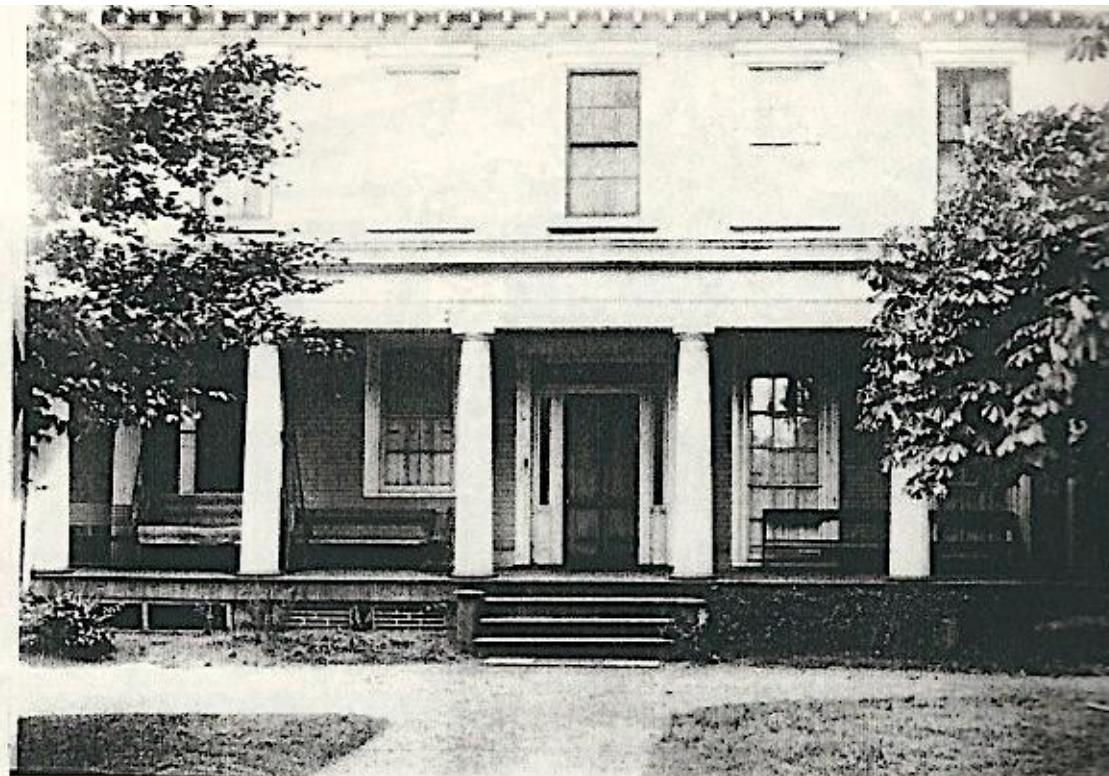
n.d. [After 1887, when Edward H. Stokes' tenure concluded] (Edward A. Stokes Period)

Pre-1934 photograph of the north elevation. This photograph details the north elevation of the original section of the house. The photograph, similar to the 1850 engraving, shows a porch that contains the same form and details depicted in the engraving-six fluted, Doric columns with fluted pilasters. The entrance, accessed by four steps contains a paneled wooden door fronted by a screen door. The door surround is comprised of wide wooden trim which forms sidelights and an 8 light transom. The window trim is notably wide, and the trim on the floor to ceiling windows is of a different profile, confirming that these windows were altered within the c.1815-1850 period, the dates the porch was constructed. Again, window sash are mostly 6/6 configuration-the floor to ceiling windows contain 12/6 sash.

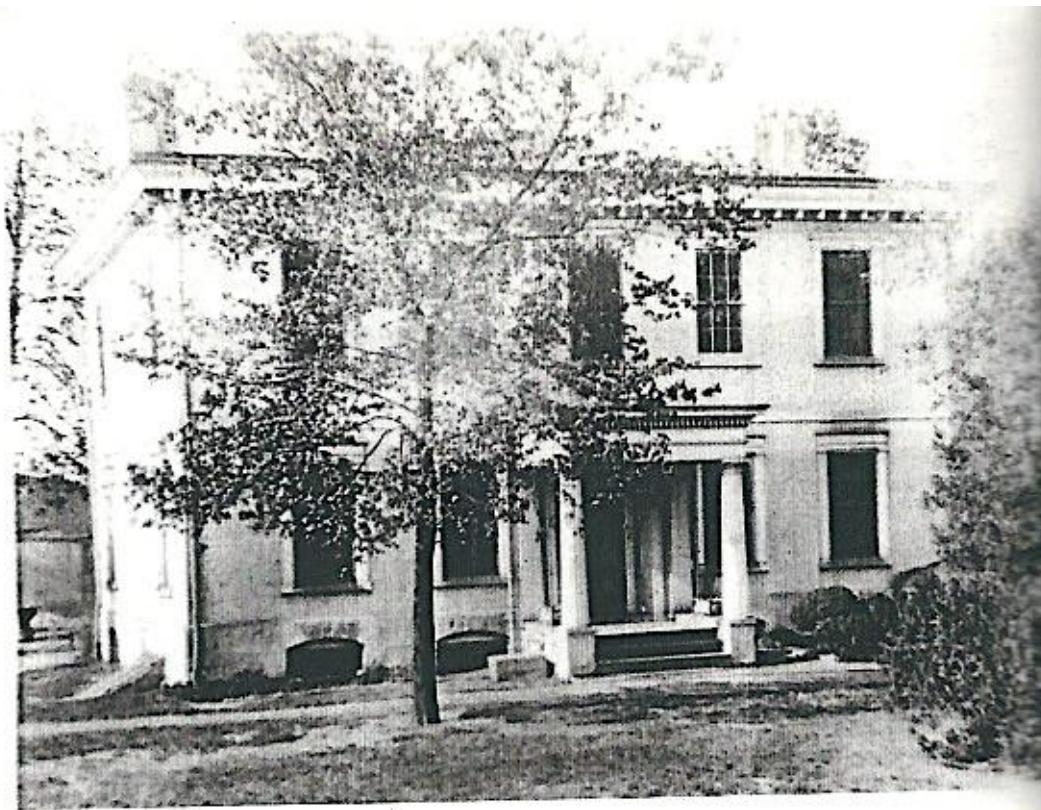
n.d. [After 1887]

Pre-1934 photograph of the south and west elevations. Notes: This photo depicts the south and west elevations of the original section of the house. Details of the entrance porch include fluted Doric columns and a wide soffit band-identical to those on the north elevation porch-probably indicating these to be of the same date. This south elevation porch soffit, however is crowned with dentilated molding, a feature missing from the north elevation porch-possibly denoting that the south elevation entrance was the primary one at this time. Note bulkhead door on west facade.

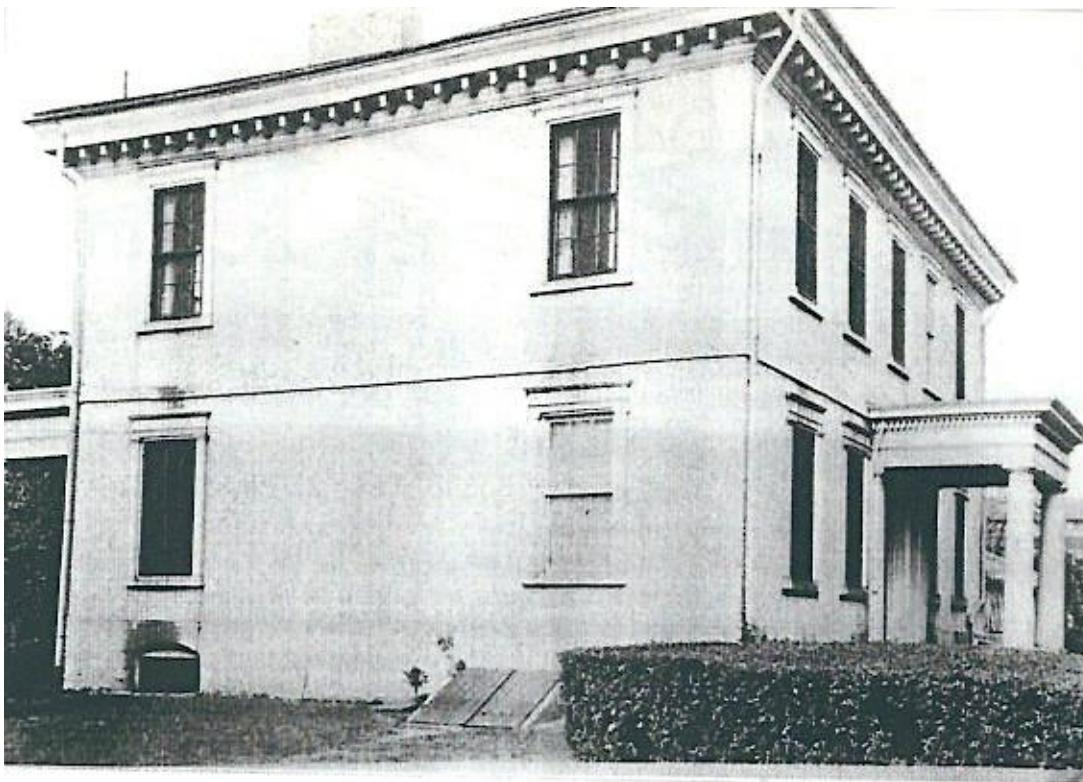
n.d. [After 1887]

Pre-1934 photograph of the west and south elevations. Note bulkhead door. This was located appox. where the present utility tunnel entrance is now.

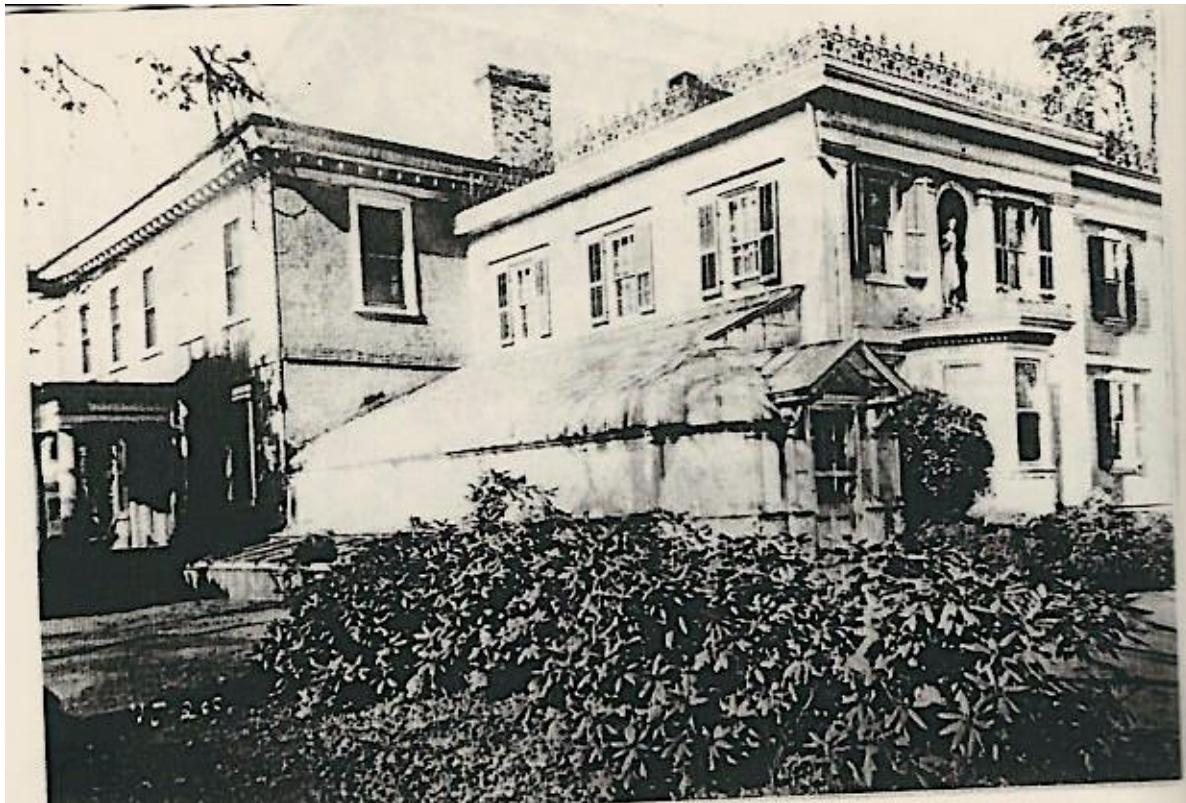
n.d. [After 1887]

Pre-1934 photograph of the south and east elevations. The most notable feature in this photo is the greenhouse-a different structure than the one depicted in the c.1882-1887 photograph. This greenhouse is depicted in a 1927 map. Notes: the two distinct northeast /southeast sections of the additions can be easily seen in this photo. The northeast section is frame/clapboard and the southeast section is masonry. Windows on the original house as well as the additions are 6/6.

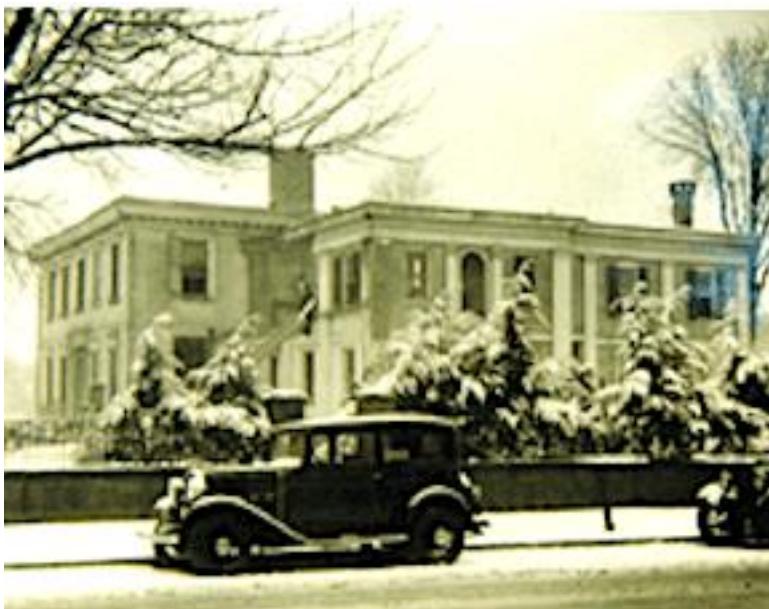
The WPA Restoration 1934-1936

- ◆ 1929 Edward A. Stokes conveys Trent House to the City of Trenton under stipulation that it be restored to its original (Colonial) appearance.
- ◆ Restoration was financed by the Federal Government through The Civil Works, The Emergency Relief and the Public Works Administration. (WPA.)

- ◆ Planning (and selective demolition) began 1933 under direction of Trustees of Trenton Free Public Library
- ◆ J. Osborne Hunt was supervising architect. Samuel Mountford was researching architect and directed the mechanicals installation.

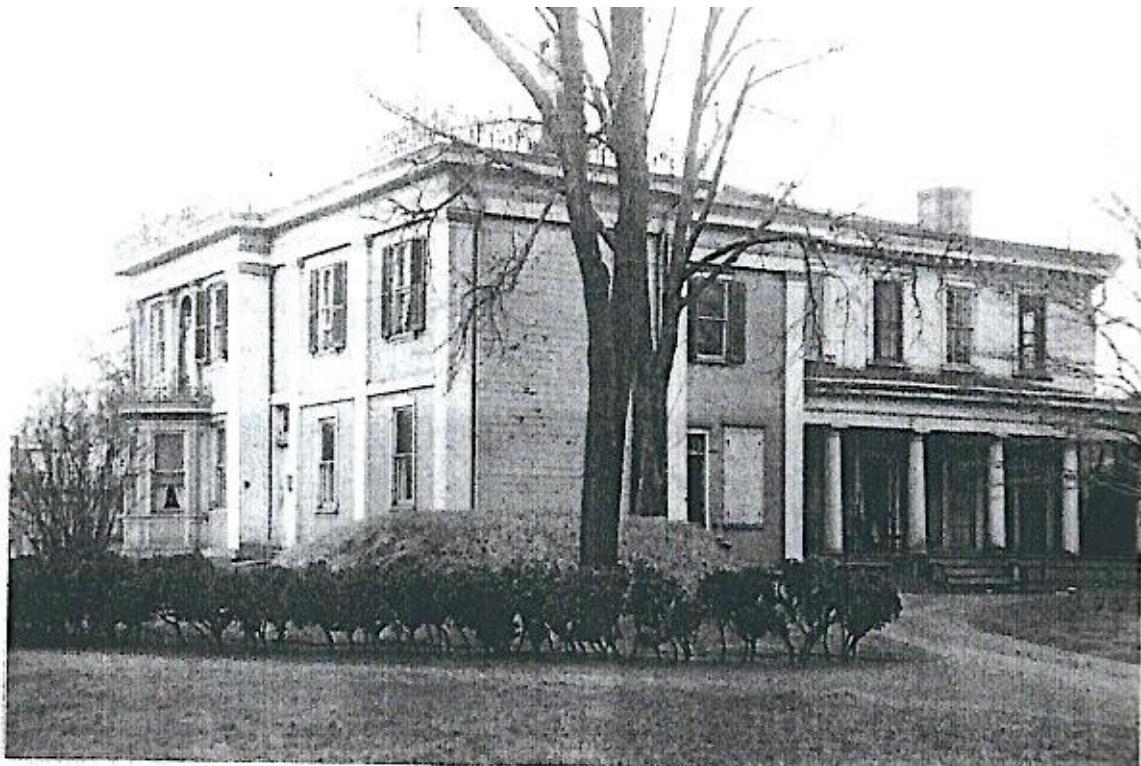
1/9/1934

Photograph of the east and north elevations pre-restoration. Photo 61, WPA Project 2976. The two distinct sections of the additions can readily be seen In this view.

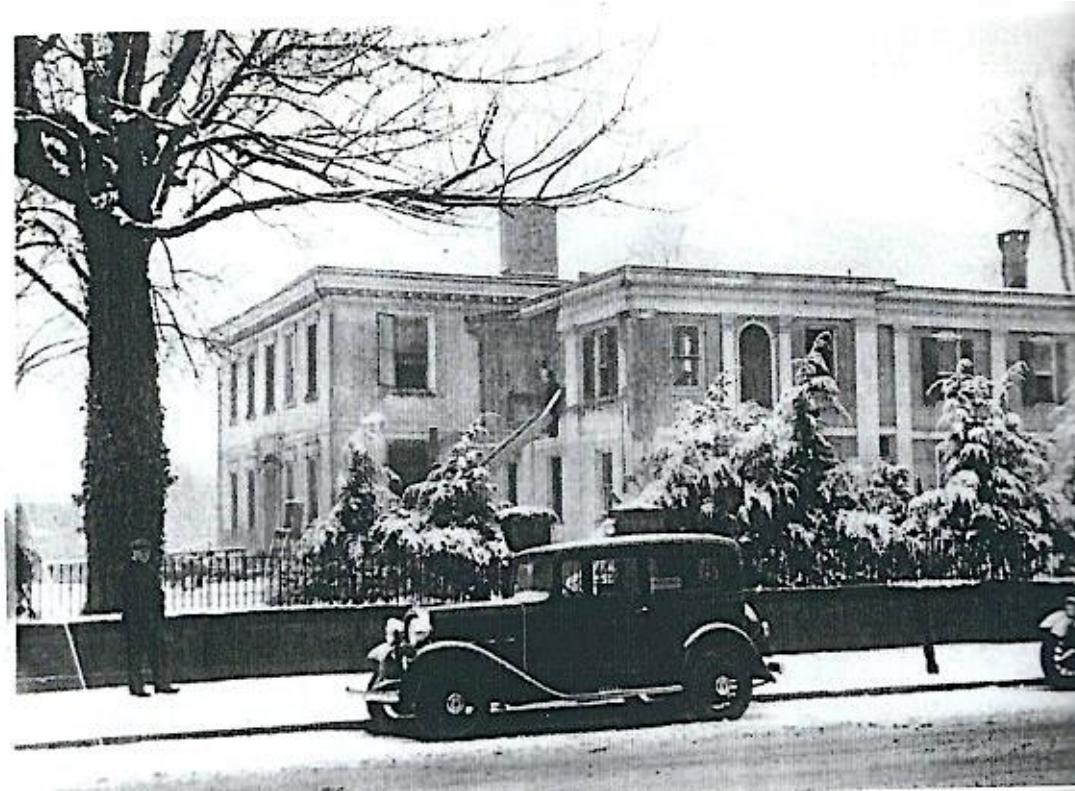
2/1/1934

**Photograph of south and east elevations. Photo 97, WPA Project 2976
This view was taken during the WPA removal of the greenhouse.**

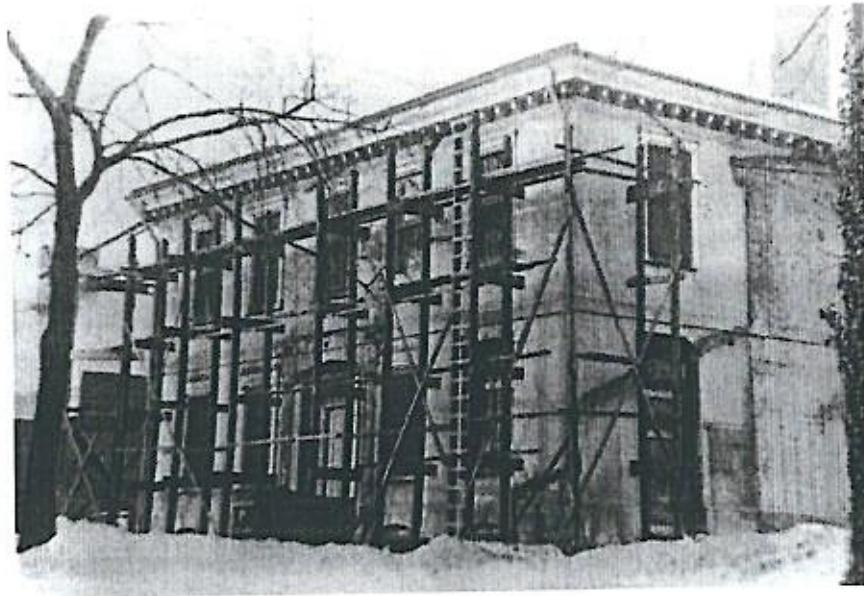
n.d. [1934]

View of the south and east elevations. This photo was taken after the removal of the additions, greenhouse and porches.

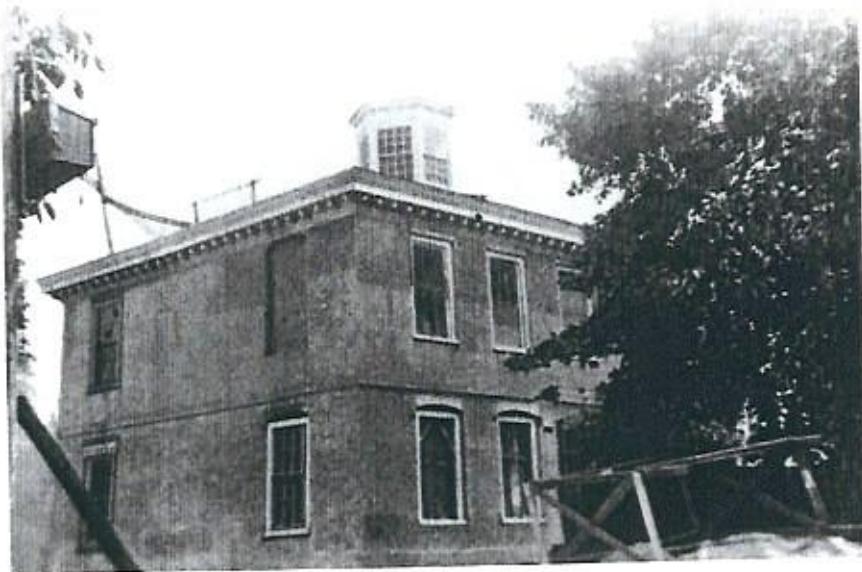
n.d. [1934]

View of the south and west elevations. This image documents the restoration of the cupola and the removal of the 6/6 sash, and shows that the brickwork has likely been acid cleaned and/or sandblasted.

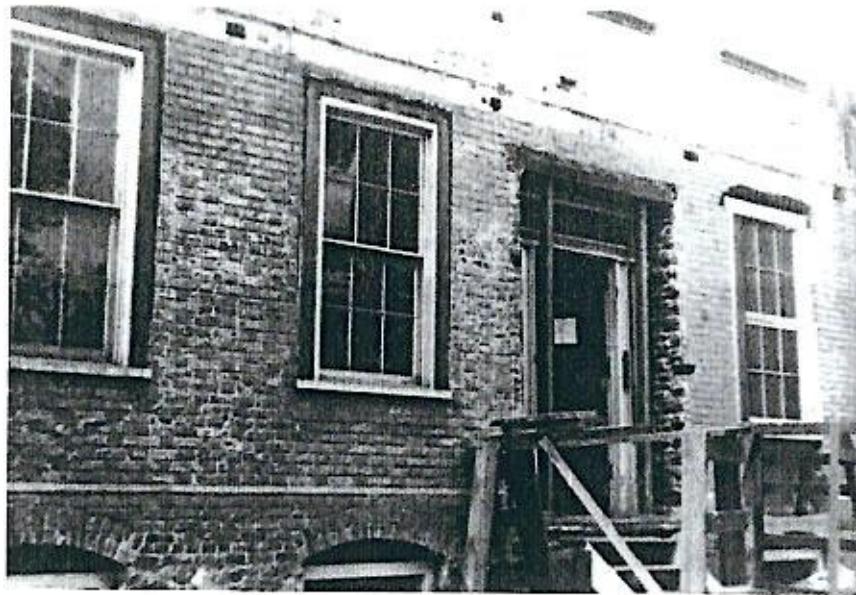
n.d. [1934]

**North elevation entrance photo detail taken during the WPA restoration.
This shows the north elevation entrance after removal of porch which spanned entire length
of the elevation.**

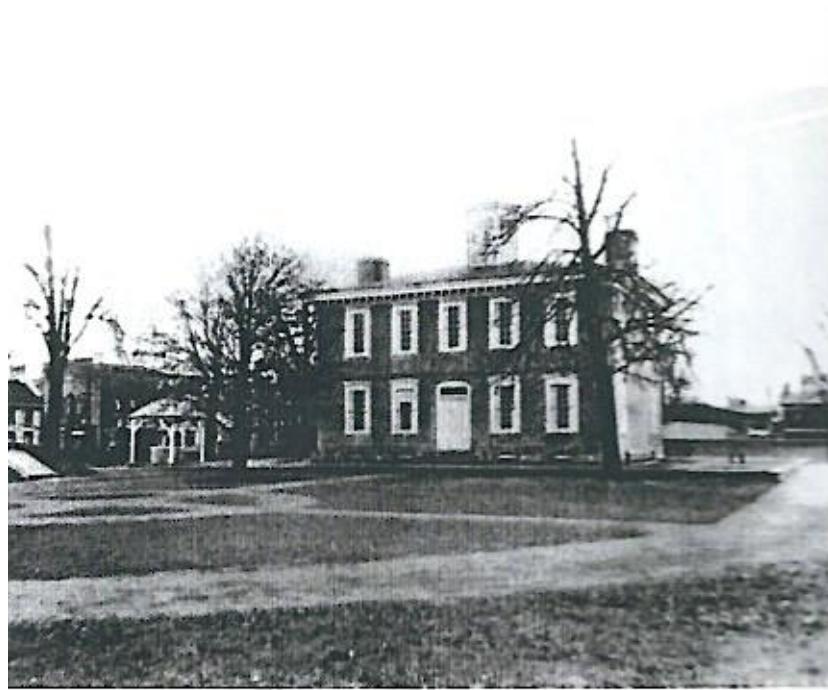
n.d. [1936]

**Photograph of the north elevation after the WPA restoration.
This image depicts the site from the north. Note the
completed well and well shed and root cellar.**

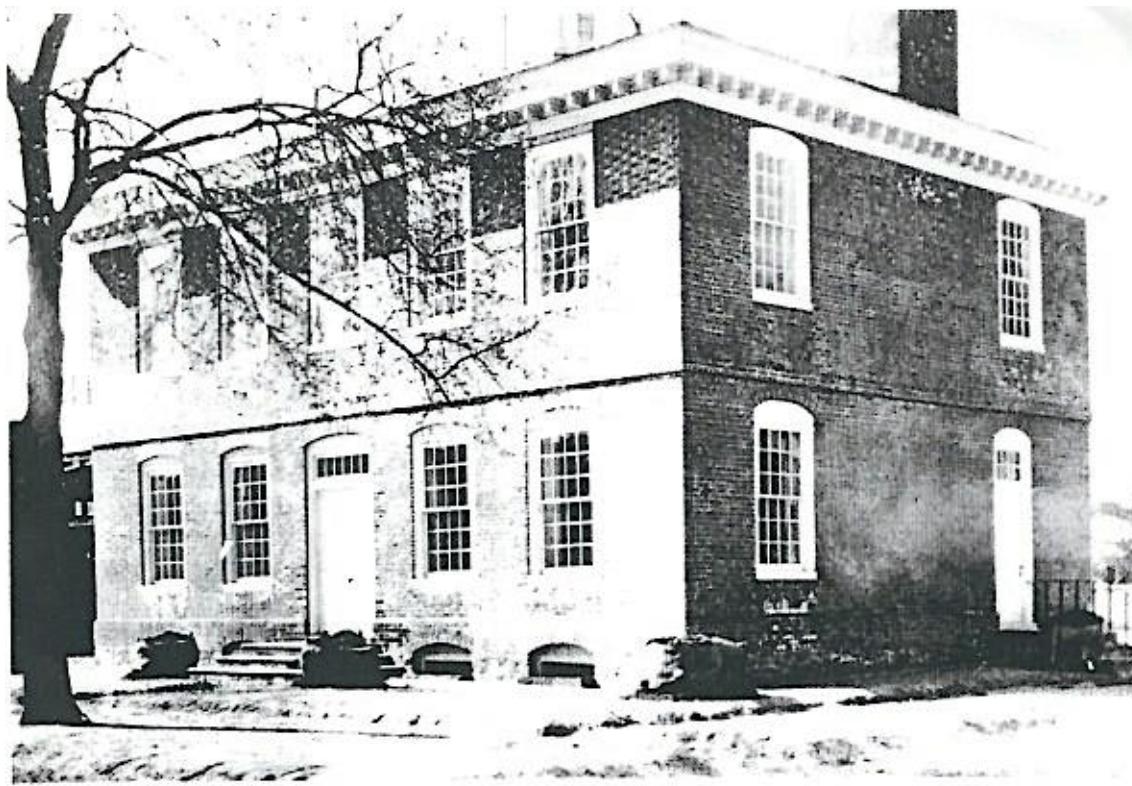
1936

Photograph of the south and east elevations after the WPA restoration.

This image, taken after the restoration was complete shows notable changes that include the removal of the additions, the removal of the porches, the reconstruction of the cupola, the reconfiguration of the window openings and the installation of 12/12 sash. Also, the carriage house was altered to a Colonial appearance. (Not shown)

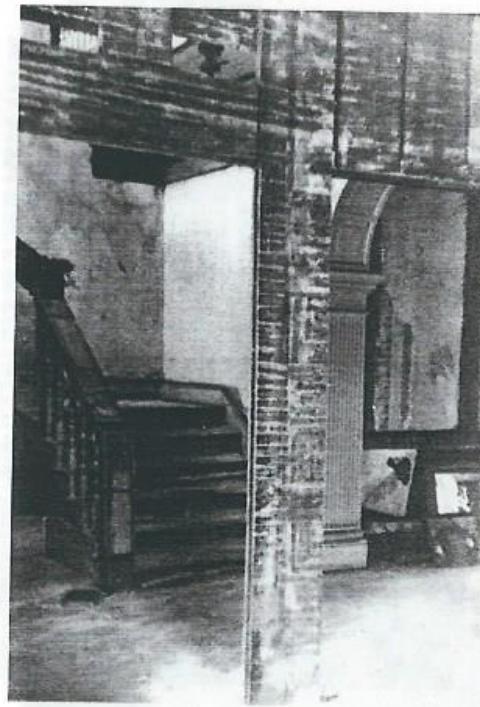
Oak plank and
lath, first floor

- ✧ Interior walls plastered (over oak plank and lath) with wood paneling and trim
- ✧ Window sash and most hardware imported
- ✧ Exterior paint-cornice, doors, sash, etc.:

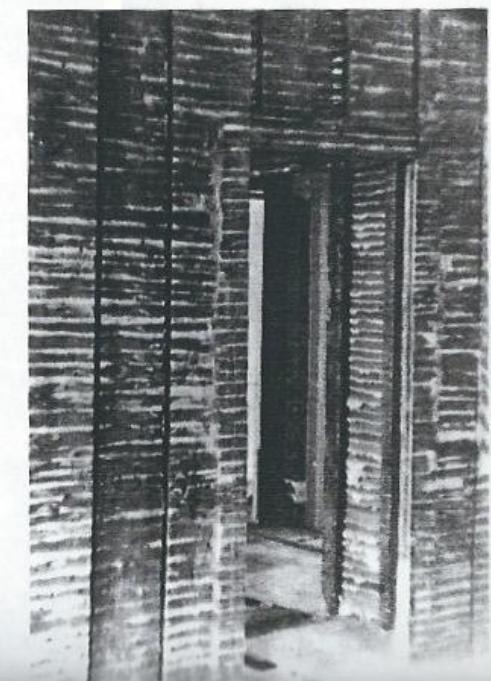
Oak plank and
lath, second floor
bedroom

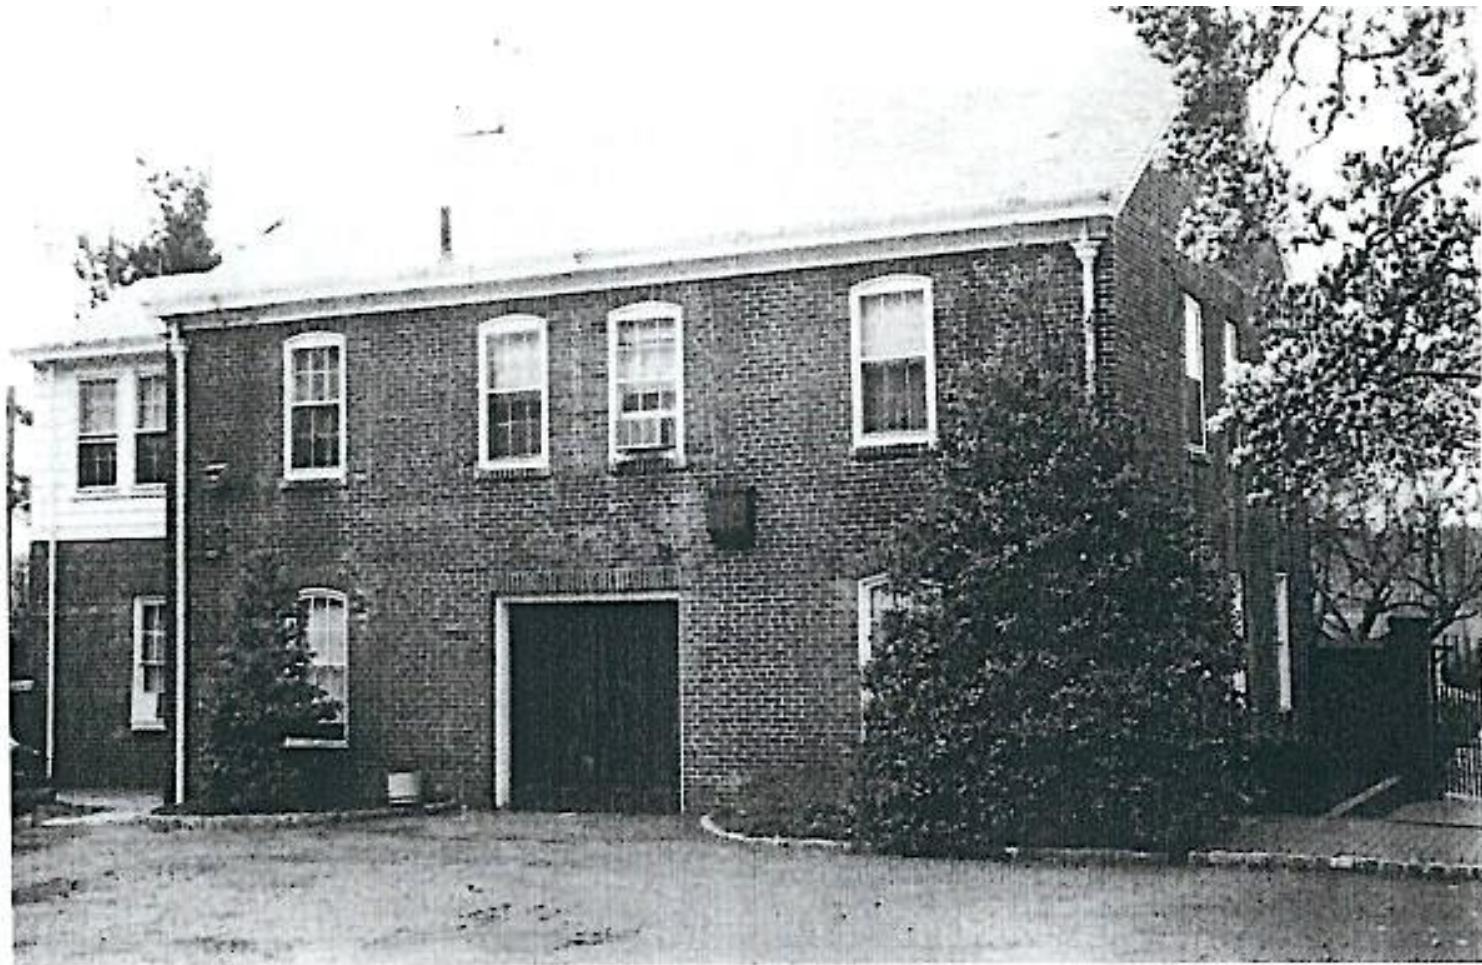
Carriage House. 1996

View of the East Elevation

This Carriage House, erected between 1882 and 1890 replaced an "L" shaped frame building built before 1874 and demolished by 1882. This Carriage House was remodeled to a Colonial appearance during the WPA restoration of 1934 to 1936.
